# Hickory Point Homeowner's Association 2018 Reserve Study

July 2018

## Reserve Study

*Dated 16 July 2018*

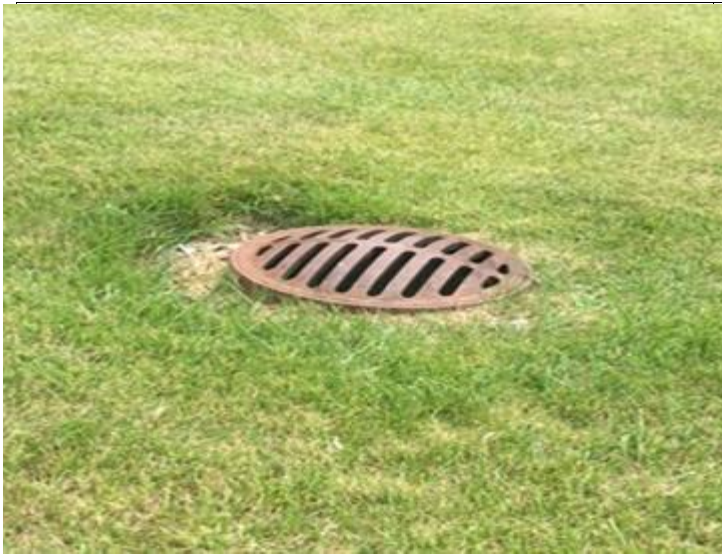
runoff. These easements, storm sewers, and catch basins must be kept clear of debris, leaves, branches, trees, and structures such as sheds, patios, or play structures. Property owners are not allowed to compromise these easement areas that could affect the storm drainage for the entire development. These permanent easements allow access for repair and replacement of failed storm sewers as well access for cleaning and maintenance of the storm sewer system. During our inspection of the development no known surface ponding or settlement areas over storm sewers were observed. There was one catch basin at the east side of Nutmeg Park near Nutmeg Drive that was not properly backfilled that should be regraded to avoid pedestrian tripping.

Fill around existing Catch Basin in Nutmeg Park

1. Grading and fill at catch basin at the east side of Nutmeg Park.
2. Clean all catch basin sumps on a regular basis.
3. Remove heavy brush and trees from detention basin inlet pipe and outlet structure.
4. Replace fractured curbs at the Hickory Pointe boulevard entrance island.
5. Repair or replace bituminous paths at parks.

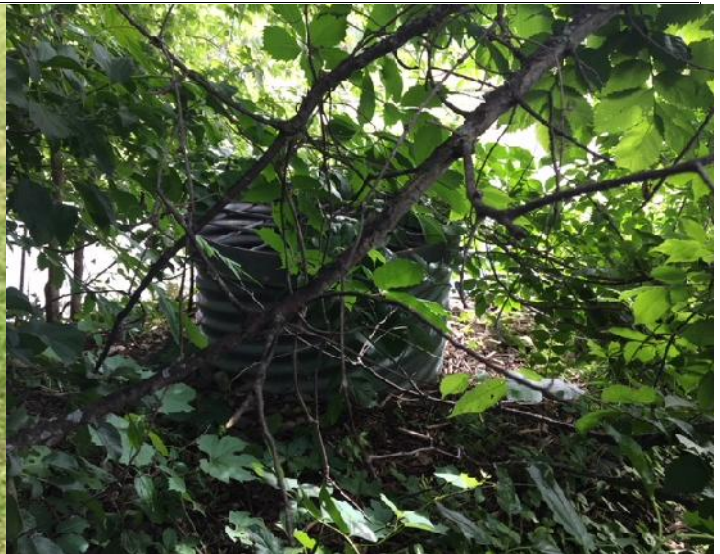
There is one large detention basin that collects, stores and discharges the storm runoff from this entire development within the area designated as Buckley Park. The detention basin is located along the eastern property line adjacent to Munger Road between Hickory Pointe Boulevard and Ginkgo Drive behind the homes along the east side of Buckley Drive. There is access through an easement from Buckley Drive and along Munger Road. This detention basin has become overgrown with woody plants and small trees that are beginning to clog the basin inlet and outlet pipes with organic debris. This basin should be brush cleared with removal of the cut materials off-site. These small trees and woody plants need to be cut down and cleared from the pipe openings. If the outlet pipe becomes blocked with debris and ice it could cause flooding.

Remove Brush and Small Trees at Detention Outlet

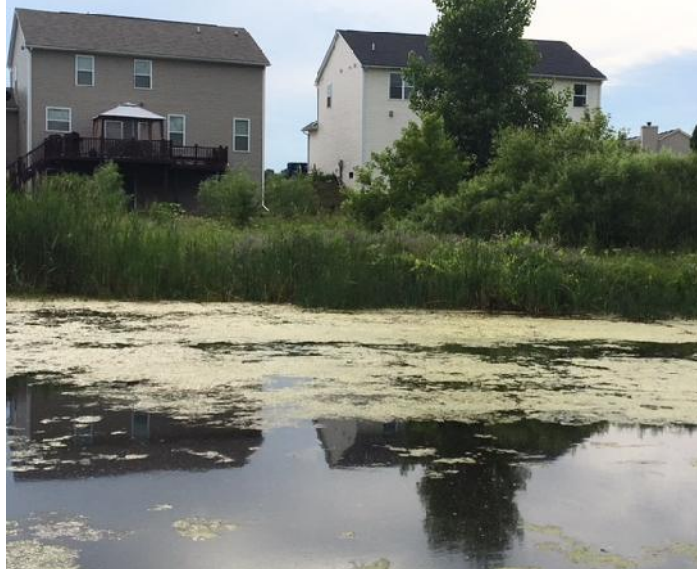
Remove Brush from Detention Basin Inlet Sewer

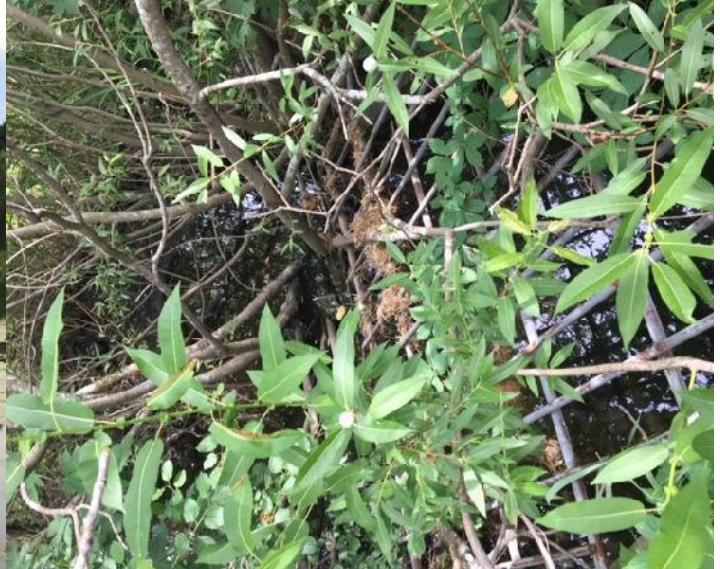
Remove Brush from Detention Basin Inlet Sewer

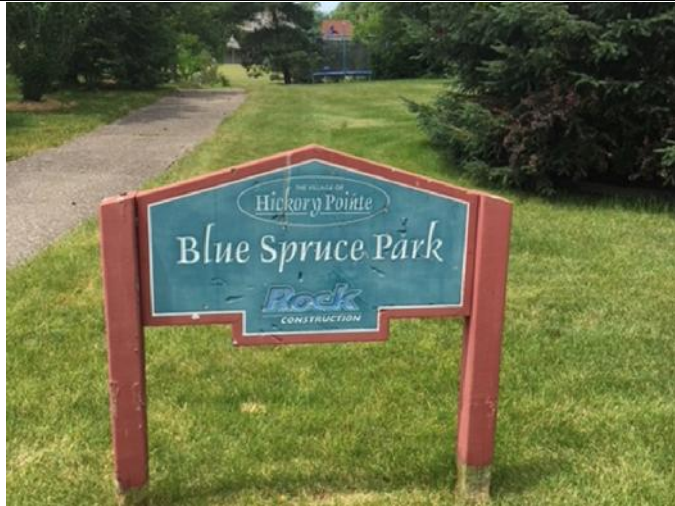
***Open Park Areas & Signs:*** There are bituminous pathways located in all of the common space parks within this community. The pathway is continuous from the pool building through Walnut Park to Nutmeg Park and through Hickory Park to Pecan Park. There are also short bituminous paths into all of the neighborhood common space parks. These paths are in varying condition ranging from very poor to newly paved condition with the majority of these bituminous paths in poor condition. Some repairs are needed as soon as possible to avoid pedestrian accidental trips and falls, with planned reconstruction in the future. The common space open parks are predominantly well maintained lawn areas without other vegetation or trees. A complete inspection was performed of all bituminous pathways and the park signs.

Maintain Bit Pathways and Park Signs

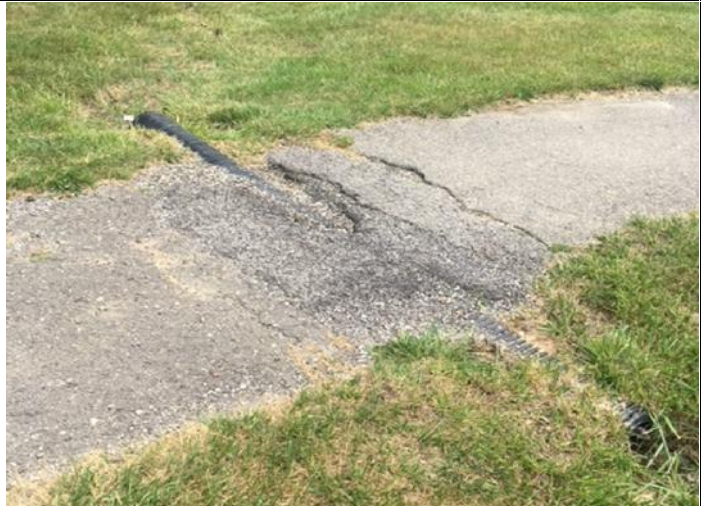
Replace Culvert & Repair Bituminous Pathway
