# Hickory Point Homeowner's Association 2018 Reserve Study

REVISED  
December 11, 2018

Engineering Technologies Corporation  
802 Phoenix Drive  
Ann Arbor, MI 48108  
(734) 944-2020 <http://www.etcinc.com/>

## Reserve Study

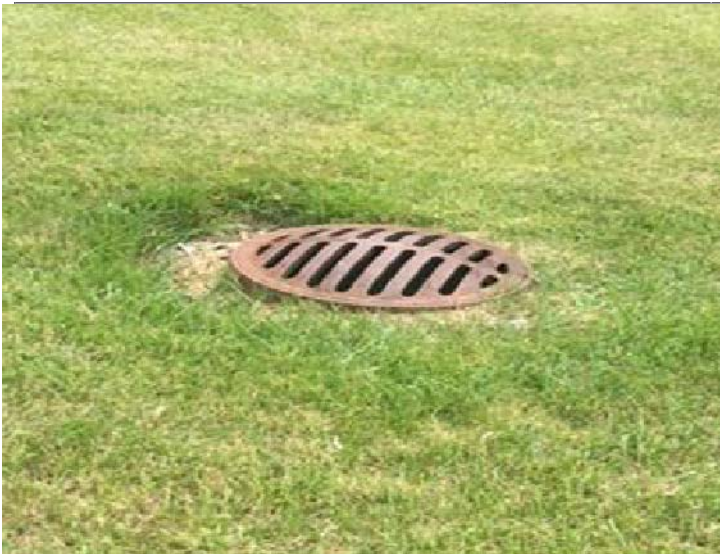
runoff. These easements, storm sewers, and catch basins must be kept clear of debris, leaves, branches, trees, and structures such as sheds, patios, or play structures. Property owners are not allowed to compromise these easement areas that could affect the storm drainage for the entire development. These permanent easements allow access for repair and replacement of failed storm sewers as well access for cleaning and maintenance of the storm sewer system. During our inspection of the development no known surface ponding or settlement areas over storm sewers were observed. There was one catch basin at the east side of Nutmeg Park near Nutmeg Drive that was not properly backfilled that should be regraded to avoid pedestrian tripping.

Fill around existing Catch Basin in Nutmeg Park

1. Grading and fill at catch basin at the east side of Nutmeg Park.
2. Clean all catch basin sumps on a regular basis.
3. Remove heavy brush and trees from detention basin inlet pipe and outlet structure.
4. Replace fractured curbs at the Hickory Pointe boulevard entrance island.
5. Repair or replace bituminous paths at parks.

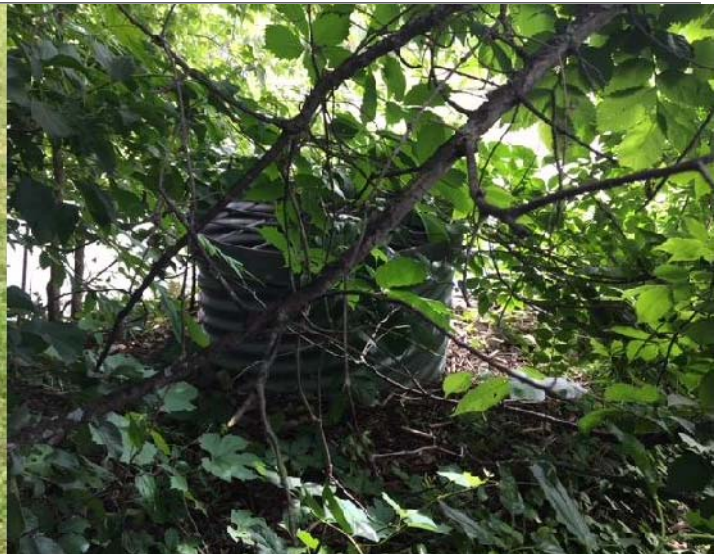
There is one large detention basin that collects, stores and discharges the storm runoff from this entire development within the area designated as Buckley Park. The detention basin is located along the eastern property line adjacent to Munger Road between Hickory Pointe Boulevard and Gingko Drive behind the homes along the east side of Buckley Drive. There is access through an easement from Buckley Drive and along Munger Road. This detention basin has become overgrown with woody plants and small trees that are beginning to clog the basin inlet and outlet pipes with organic debris. This basin should be brush cleared with removal of the cut materials off-site. These small trees and woody plants need to be cut down and cleared from the pipe openings. If the outlet pipe becomes blocked with debris and ice it could cause flooding.

Remove Brush and Small Trees at Detention Outlet

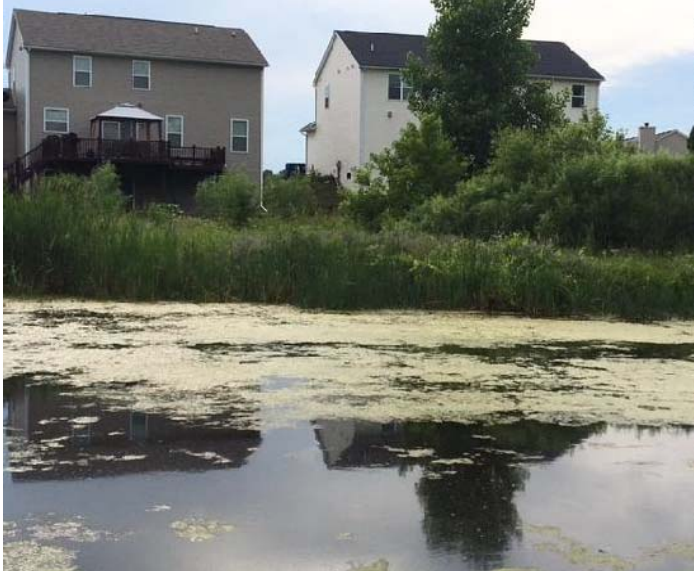
Remove Brush from Detention Basin Inlet Sewer

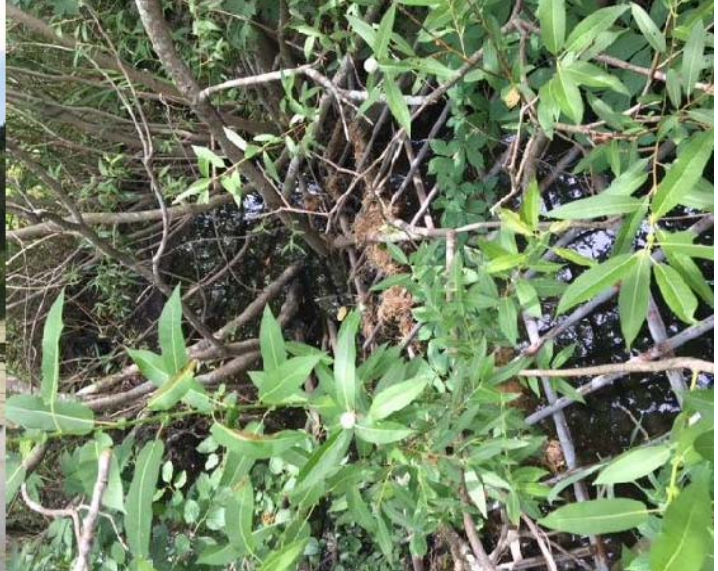
Remove Brush from Detention Basin Inlet Sewer

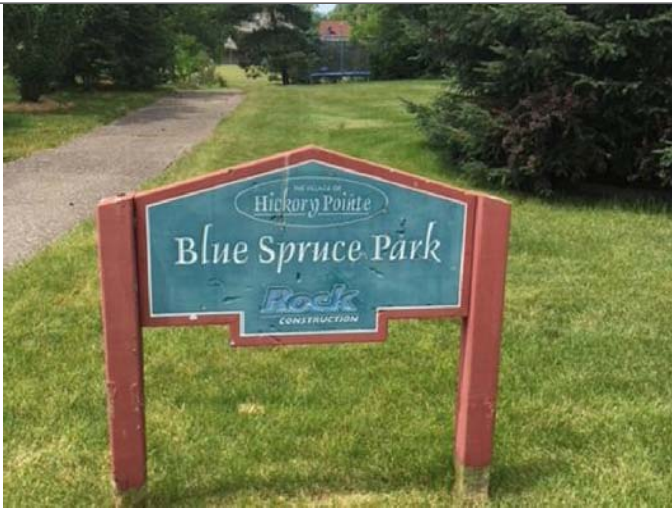
***Open Park Areas & Signs:*** There are bituminous pathways located in all of the common space parks within this community. The pathway is continuous from the pool building through Walnut Park to Nutmeg Park and through Hickory Park to Pecan Park. There are also short bituminous paths into all of the neighborhood common space parks. These paths are in varying condition ranging from very poor to newly paved condition with the majority of these bituminous paths in poor condition. Some repairs are needed as soon as possible to avoid pedestrian accidental trips and falls, with planned reconstruction in the future. The common space open parks are predominantly well maintained lawn areas without other vegetation or trees. A complete inspection was performed of all bituminous pathways and the park signs.

Maintain Bit Pathways and Park Signs

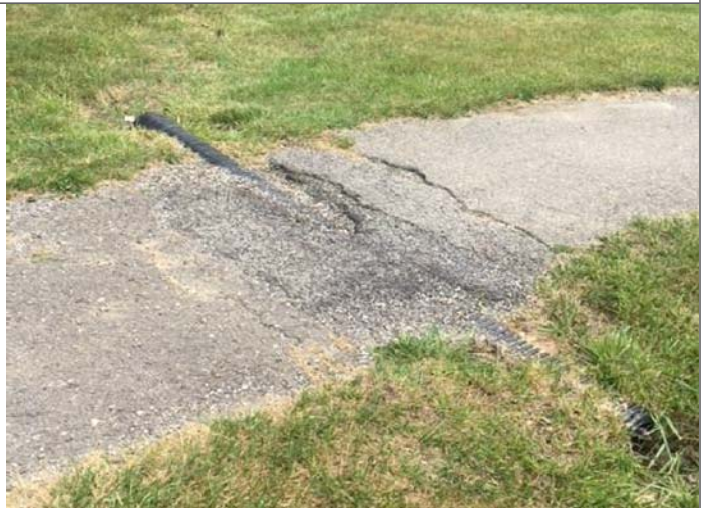
Replace Culvert & Repair Bituminous Pathway
